## 2023 Robles Fish Passage Facility Progress Report

Casitas Municipal Water District  
1055 Ventura Avenue  
Oak View, California 93022

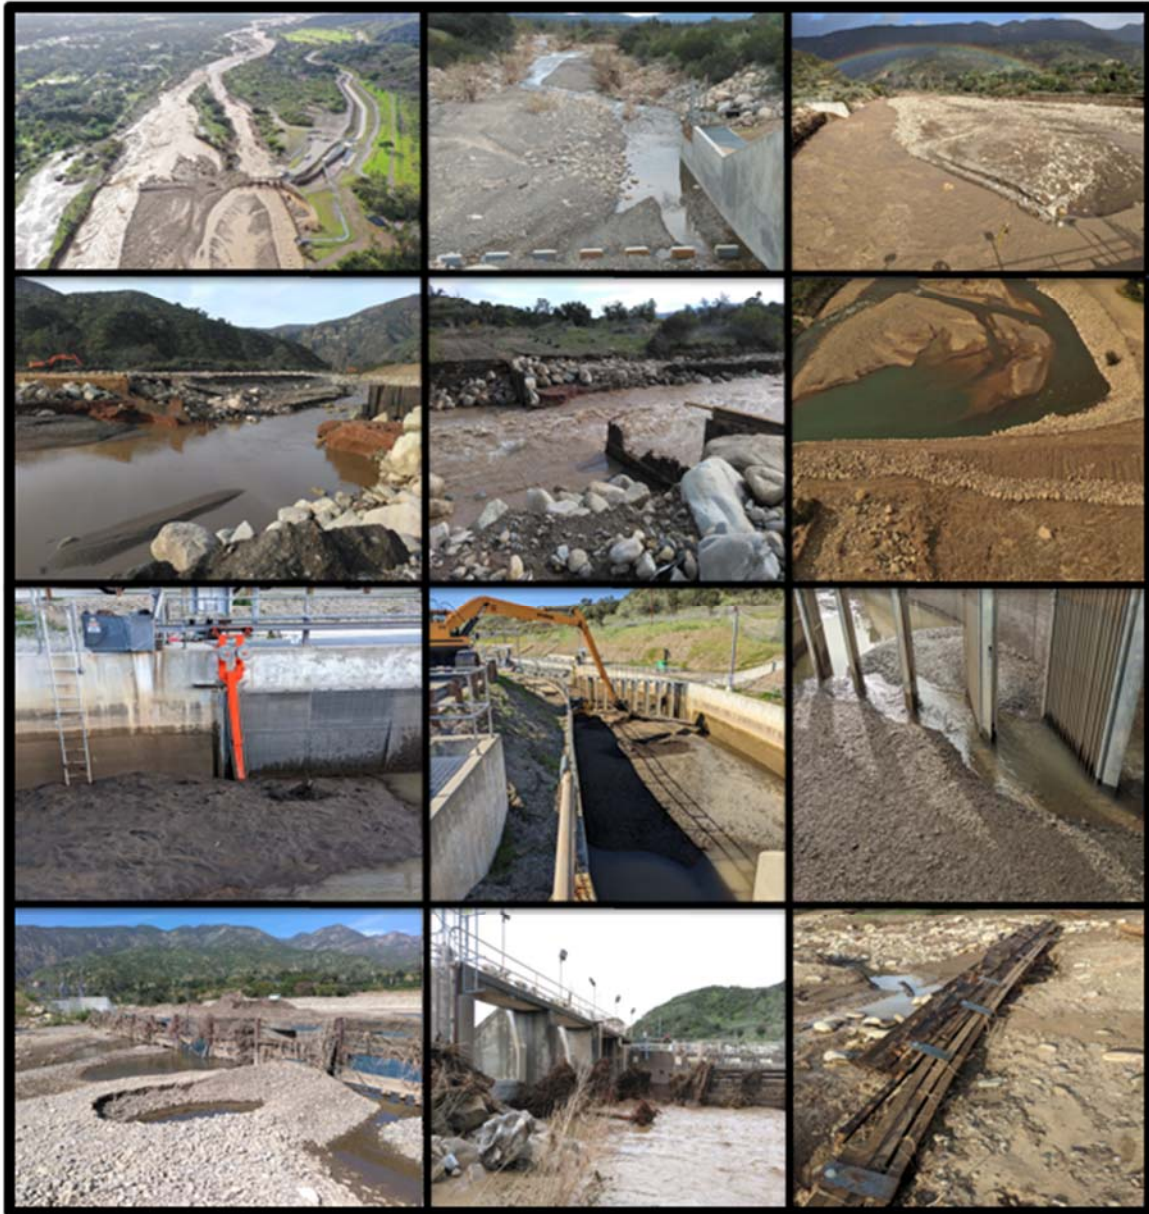
Photos illustrating the range of flood damage to the Robles Fish Passage Facility in 2023 that included forebay and entrance pool sedimentation (top row), timber cutoff wall breach and temporary repair (2<sup>nd</sup> row), sedimentation inside of facility (third row), and debris fence damage, spillway debris, and section of cutoff wall deposited downstream (bottom row).

- Emergency repairs. The large storm event on 09 January 2023 caused substantial damage at the Robles Fish Passage and Diversion Facility. Two days later, the Casitas Board of Directors adopted a resolution proclaiming the existence of a "local emergency" given the clear and imminent danger to the health, safety and welfare of persons, property and environmental (fish and wildlife) resources within its jurisdiction and mission. Casitas immediately proceeded with the emergency repairs which continued until May 12, 2023. Work involved temporary repairs of the breached and damaged timber cutoff wall. Work also included restoring areas that eroded on the eastern side of the forebay, restoring areas that eroded on the western and eastern sides of the timber cutoff wall, and sediment debris removal from the forebay and screenbay.

Forebay sedimentation and high flows caused significant operational issues during 2023 and emergency repairs were made. However, these emergency repairs were temporary in nature and will need to be completed in the off-season (no/low flows) and once permitting can be completed. Casitas continues to recommend the 16-weir project remain on hold until final plans for Matilija Dam Removal Project are completed. These plans include a High Flow Sediment Bypass as part of the removal project that will likely require significant facility modifications to the Robles Fish Passage Facility project area and have not been determined. The Robles Working Group is currently developing sediment bypass alternatives to be designed, evaluated, and selected.

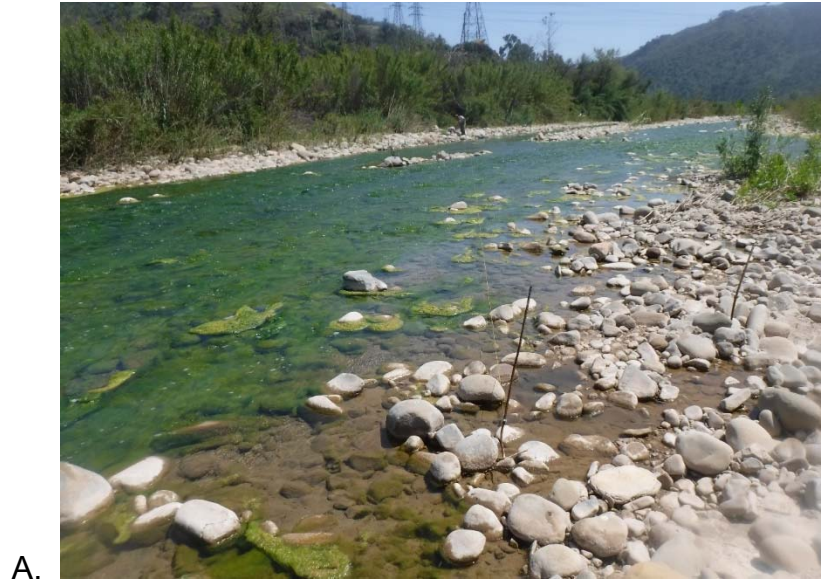
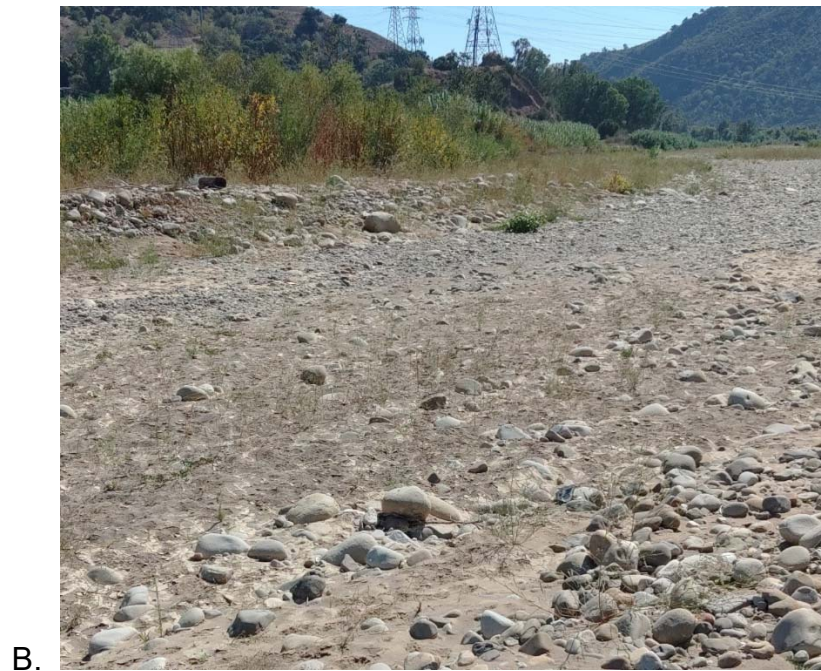
Photo comparison of Site 10-2 before (A. May 2019, 30 cfs at VRNMO) and after (B. September 2023) the large storm event in January. The stream channel thalweg has shifted 270 ft to the east and the site is no longer in the active channel.

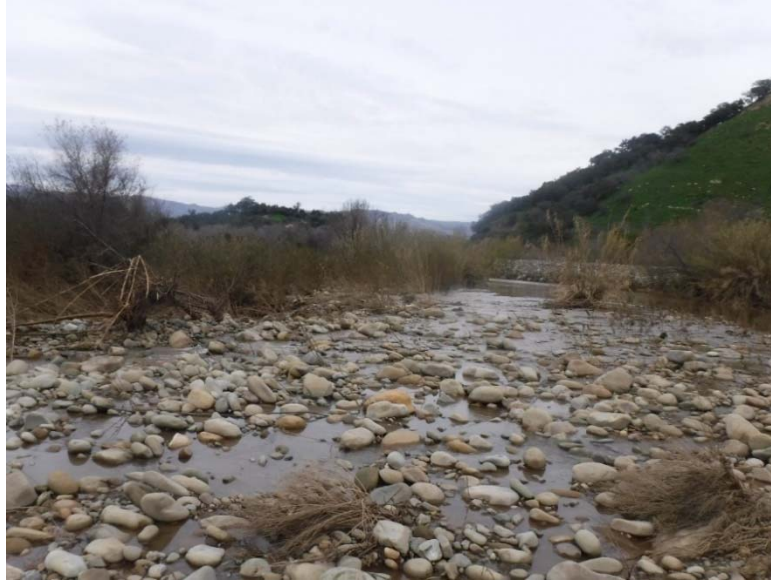
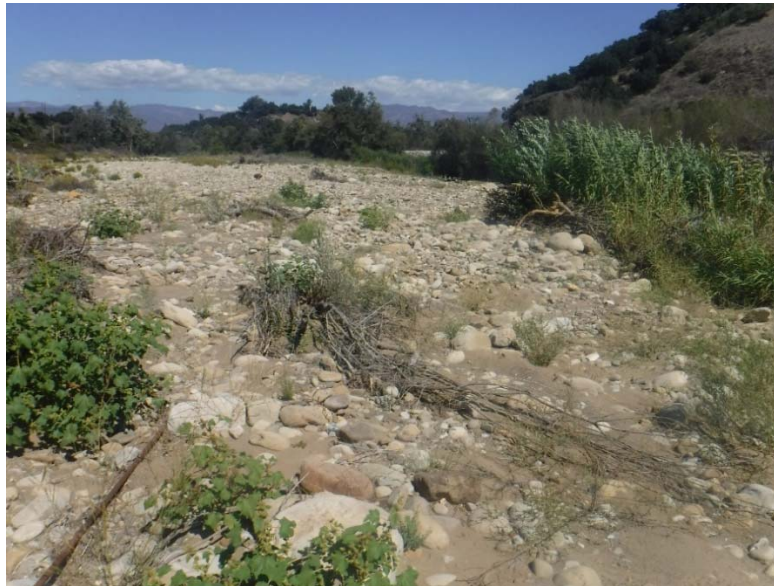
Photo comparison of Site 3-2 before (A. February 2019, 62 cfs at VRNMO) and after (B. September 2023) the large storm event in January. The stream channel thalweg has shifted 100 ft to the east and the site is no longer in the active channel.

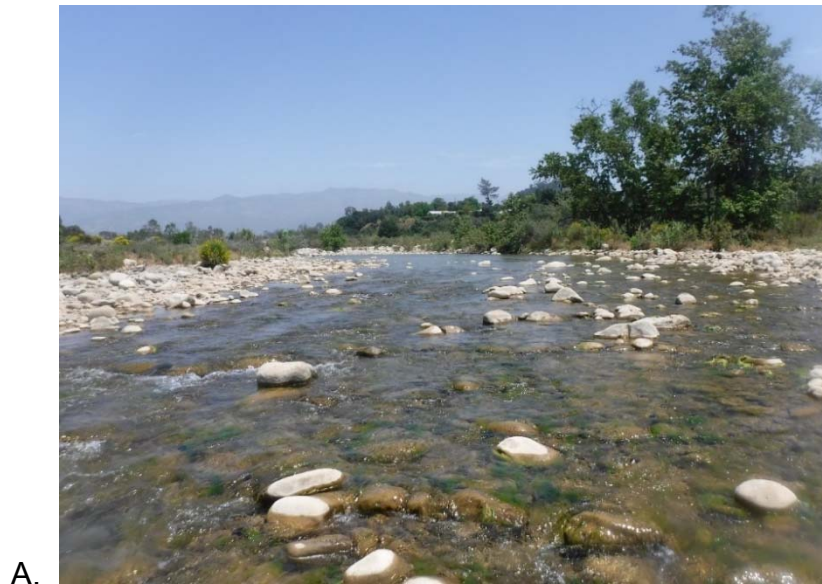
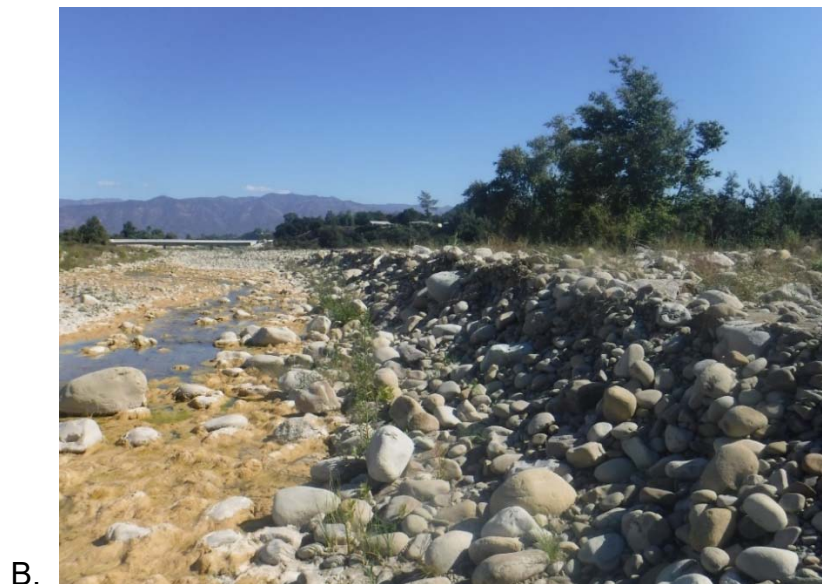
Photo comparison of Site 5-2 before (A. May 2019, 30 cfs at VRNMO) and after (B. September 2023) the large storm event in January. The stream channel thalweg has shifted 30 ft to the west and the streambed scoured 6 ft. The site is still within the active channel but has changed significantly.

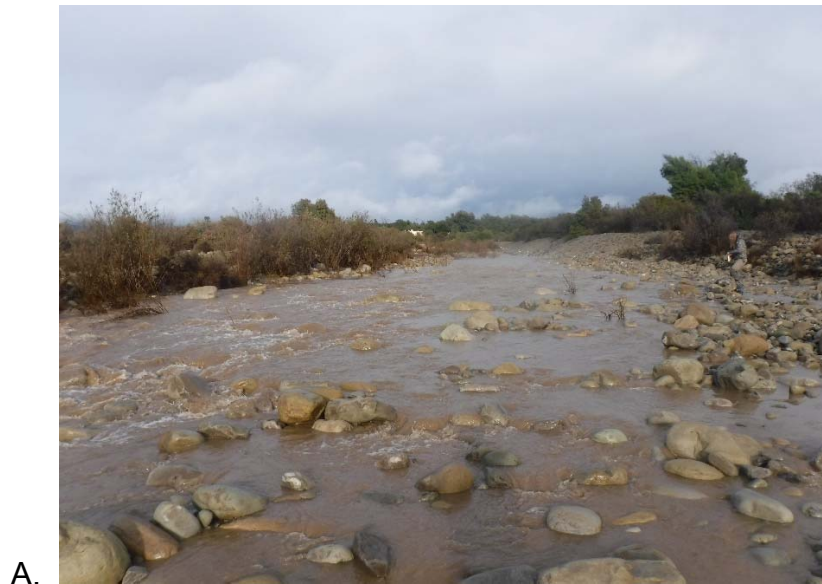
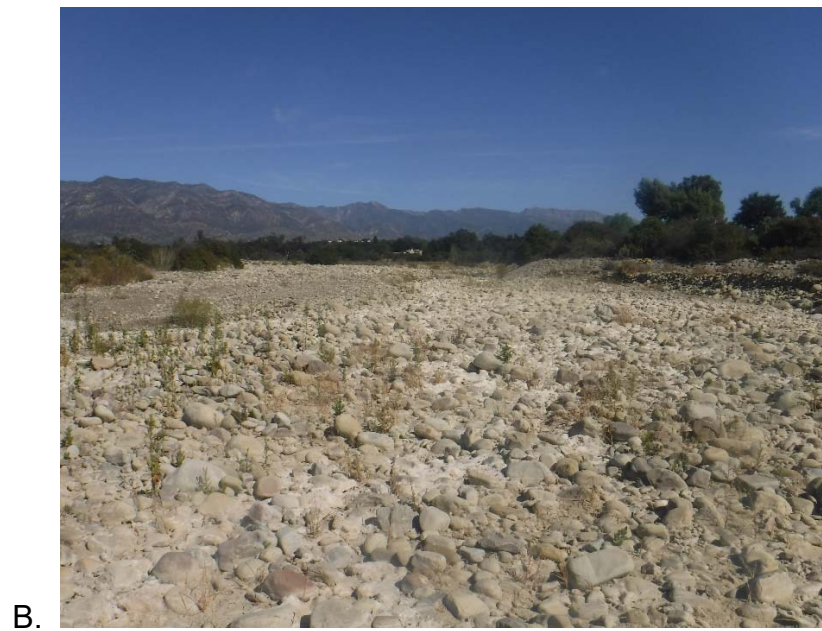
Photo comparison of Site 9 before (A. February 2019, 100 cfs at VRNMO) and after (B. September 2023) the large storm event in January. The stream channel thalweg has shifted 30 ft to the south and the streambed scoured 2 ft. The site is still within the active channel but has changed significantly.

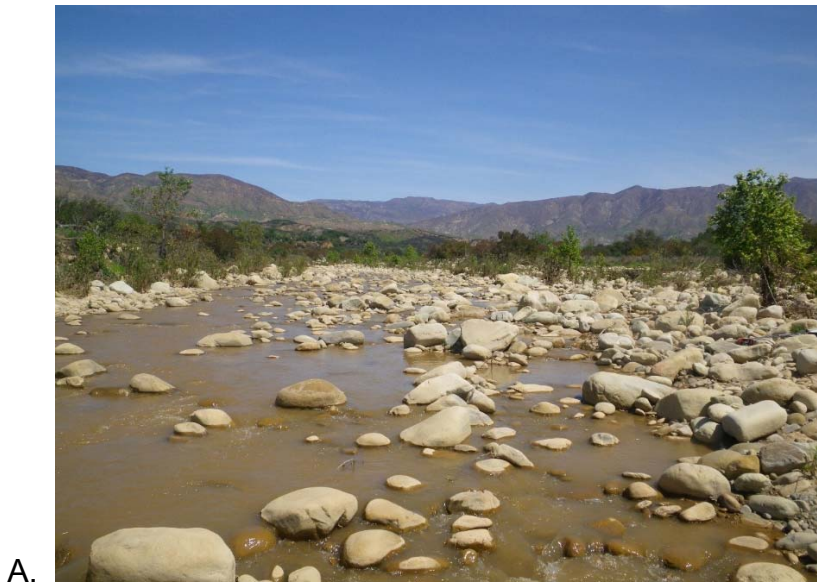
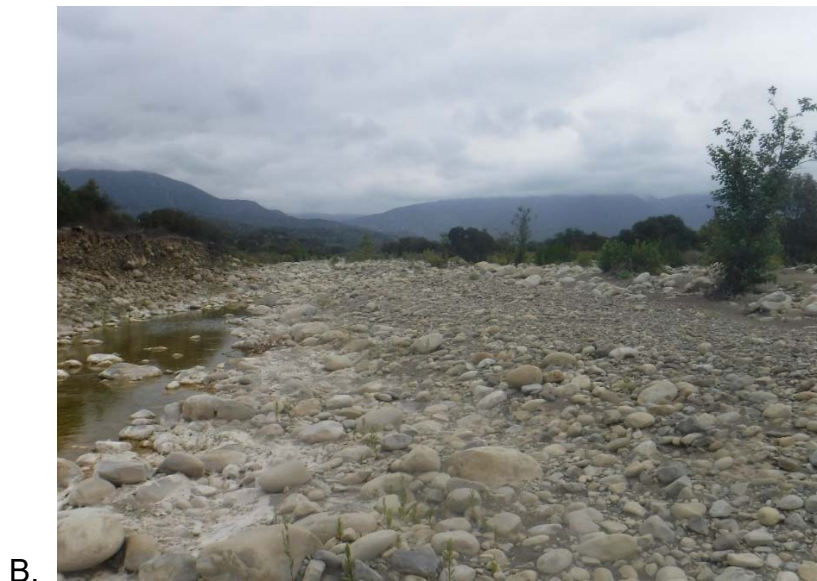
Photo comparison of Site 7 before (A. April 2018, 20 cfs at VRNMO) and after (B. September 2023) the large storm event in January. The stream channel thalweg has shifted 10 ft to the west and the streambed scoured 2-3 ft. The site is still within the active channel but has changed significantly.
