# 2024 Robles Fish Passage Facility Progress Report

Casitas Municipal Water District  
1055 Ventura Avenue  
Oak View, California 93022

*2024 Robles Fish Passage Facility Progress Report  
Casitas Municipal Water District, Oak View, CA.*

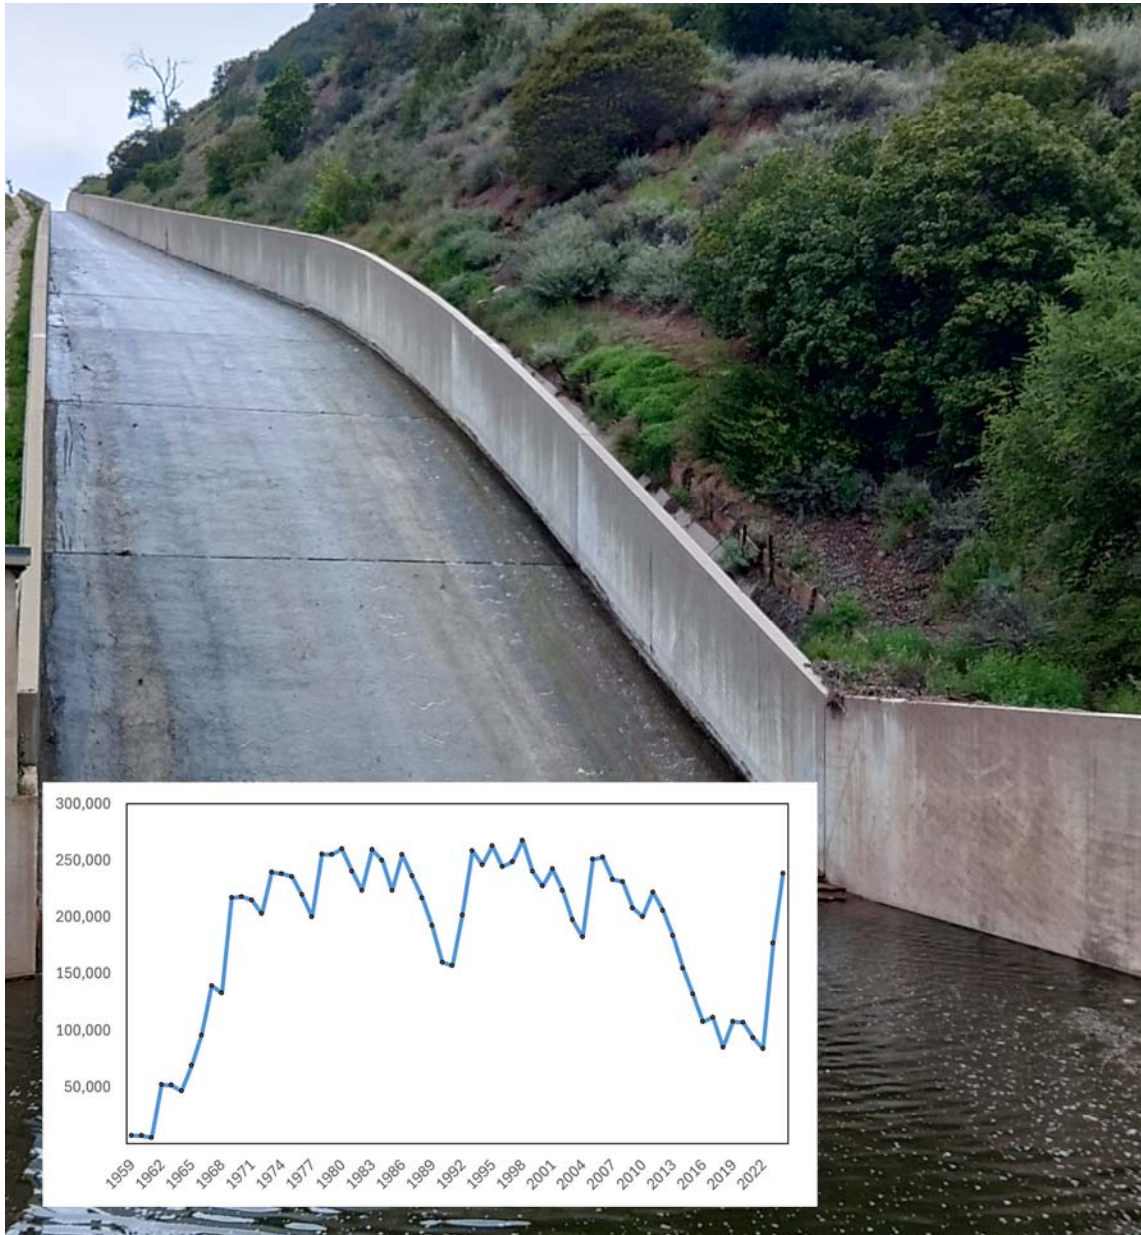
Photo of the Lake Casitas Dam spillway, which spilled for the first time since 1998, and graph of historic water storage of Lake Casitas (1959-2024).
